CONDITION AND VALUATION SURVEY REPORT

This is to certify that the undersigned surveyor did on December 14, 2011 at the request of Dave Czako for the Naval Surface Warfare Center Dahlgren Division, attend the vessel **SEA LION** to perform a condition and valuation survey. The vessel was seen while hauled at St. Mary's Yachting Center, located in Drayden, Maryland.

Name	Sea Lion
Description	Fiberglass fly bridge convertible
Builder	Ocean Yachts.
Place Built	Egg Harbor, New Jersey
Year	1983
Builders Hull Number	XYU55030M83
Official Number	US Navy 60NS832
Length Overall	<u>58</u> Feet <u>8</u> Inches*
Beam	<u>16</u> Feet <u>4</u> Inches
Draft	<u>4</u> Feet <u>4</u> Inches
Displacement	58,000 lbs
Estimated Market Value	\$ 35,000
Estimated Replacement Value	\$ 1,600,000
Suitability for Intended Service	Poor

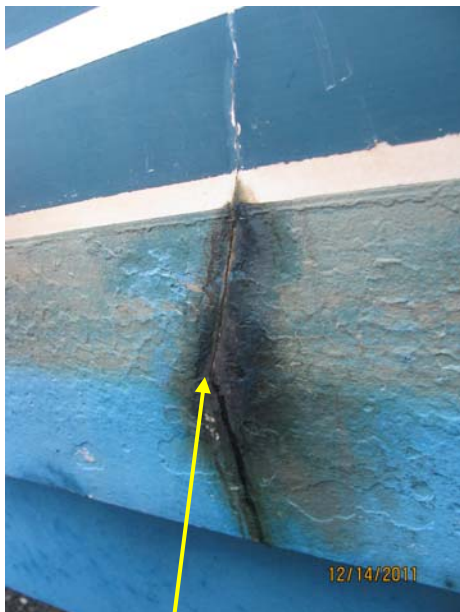
Noted Crack on Port Hull Side

The overall length of this vessel extends beyond the designed length of 55' 8", published by the manufacturer. From all appearances, the aft deck was extended by several feet. The hull was closely examined for any deficiencies that might affect the seaworthiness of the vessel. It was then observed for blistering and percussion sounded for delamination. Overall the exterior was sound, with several noteworthy exceptions; A substantial crack was observed on both sides of the hull approximately five feet forward of the transom, presumably in the area in which the hull was extended. It is more prominent on the port side than the starboard. Nonetheless, this cracking may be the result of inadequate construction practices, combined with flexing of the hull while at sea. Efforts should be taken to investigate the cause and affect a repair equivalent to accepted marine practices. In addition, an area of delamination was observed on the hull sides, just above the chine, forward of the previously mentioned cracks. These too, may a consequence of hull extension, and should be repaired.

1. Investigate the cause and affect a repair of the cracks and delamination in hull sides adjacent to cockpit.
2. Repair cracking in foredeck adjacent to port aft hatch.

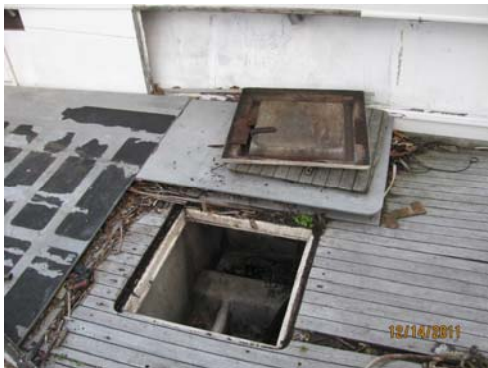
The teak deck boards, with few exceptions, have come adrift from their fastenings, and exhibit varying degrees of buckling throughout. Most, if not all of the deck will have to be replaced. The deck hatches are all degraded to the extent that they must be replaced, and the gutters are all obstructed, allowing water to enter the vessel. Even while hauled, this may have serious consequences, given the fact that the bilge pumps are presently inoperative. Access to the engine compartment is provided via a hatch located on the port side of the aft house.

3. Repair or replace aft deck and aft deck hatches and gutter drains.
4. Re-bed all salon side windows.
5. Clean engines, replace belts hoses and fuel supply lines, Prove engines as fully operational from flybridge

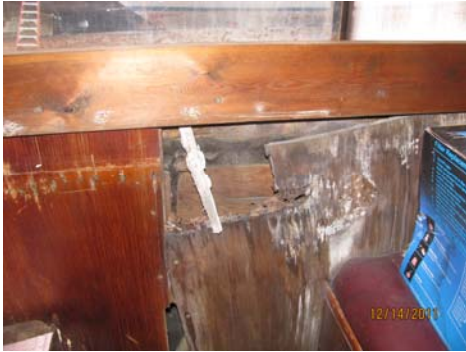
$\frac{3}{4}$ " plywood covered with carpeting or teak and holly
Vinyl liner
Bowmar aluminum using lexan lenses
Plastic
None
All of the side windows and window tracks of the salon have been leaking for an extended period of time. They should be removed and re-bedded. As a result much of the interior has decayed to the extent that most wooden components will have to be removed. Many of cupboards and cabinets are frozen closed. As previously noted, all forward spaces have been converted from staterooms to work spaces, where the liner has been either removed or is partially removed. The vessel is now provided with one operating head.

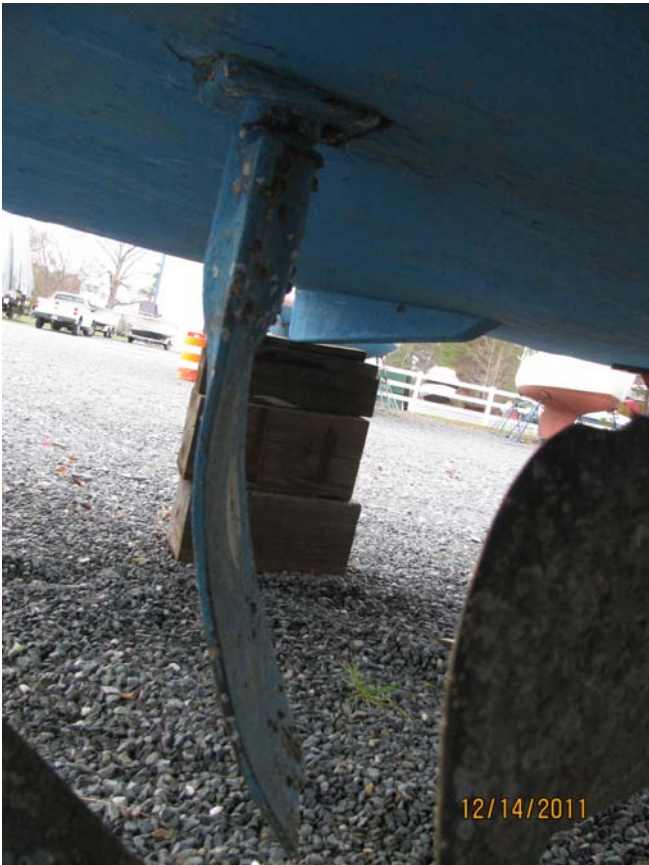
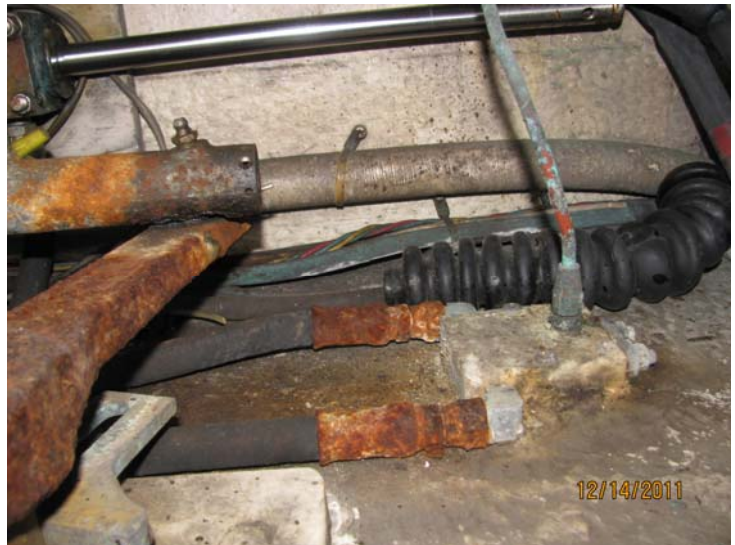
The exterior steering components of this vessel have experienced a traumatic impact, where both rudders are severely bent, as may be the rudder posts. While the associated components of the hull appear sound, efforts should be taken to withdraw both rudders for repair and the shafts examined for trueness. Additionally, many of the hydraulic terminations have deteriorated to the extent that they must be replaced, as have the associated aluminum junction blocks

6. Replace all fuel supply lines.
7. Inspect steel components of exhaust system, provide new lagging.
8. Remove and straighten or replace rudders and rudder posts: Replace all steering hydraulic lines and junction\ blocks.

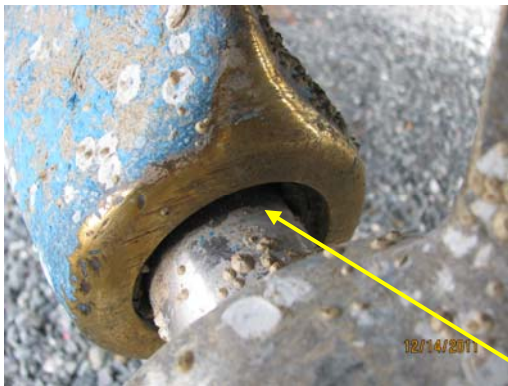
The running gear has experienced a traumatic impact resulting in the misalignment of both struts, the apparent deformation of both shafts, and a chipped starboard propeller blade. Like the structure surrounding the rudder post, the hull appears sound. That notwithstanding, given the severity of the damage observed, the propellers should be removed and tuned, the shafts withdrawn and examined for trueness, and possibly replaced, the struts removed and straightened or replaced, and the reverse gears removed, disassembled and examined for evidence of damage to the gears.

Misalignment of Shaft at Starboard Strut

9. Remove, inspect and straighten or replace all shafts and struts.
10. Remove both transmissions and inspect interior components for evidence of damage.

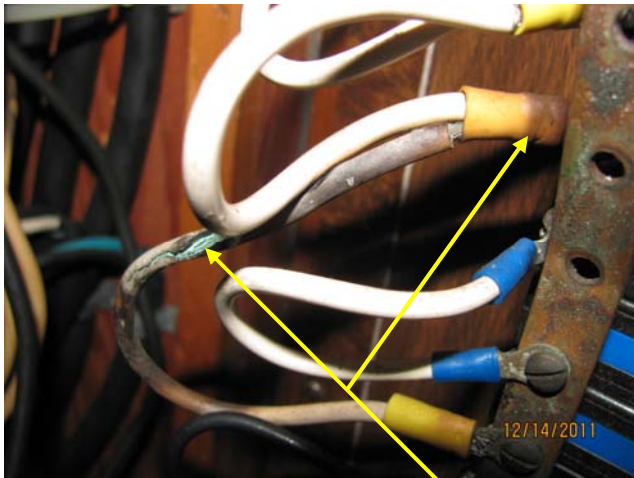
Browned Termination and Melted Sheathing

The DC circuitry is extremely confusing. Much of the wiring is not bundled, there are numerous unidentified wires and loose wire ends, and at least one termination, behind the main panel, which is browned and the associated sheathing melted. This disarray raises the possibility of fire, or the possibility of energized wires going to ground. Additionally, the batteries have been submerged, as have the engine starting solenoids, and many wires were noted as running through the bilge, several of which were very close to the starboard shaft. Efforts should be given to replacing the batteries and solenoids, eliminating any superfluous wiring, switching, and loose wire ends, re-routing the wires in the bilge, and to identifying and bundling the wires in a manner acceptable to common marine practice. The generator starting battery is crowded with an excessive number of battery terminations, which can result in a lack of continuity and an increase of resistance. Efforts should be taken to reduce the number of terminations through the installation of a buss bar. Given the number of deficiencies, it is the opinion of this office that the DC system should not be used until these recommendations are met.

11. Rewire entire DC electrical system.
12. Reconfigure AC electrical system to accommodate ABYC recommendations, and insure adequate distribution of power to electronics laboratory.

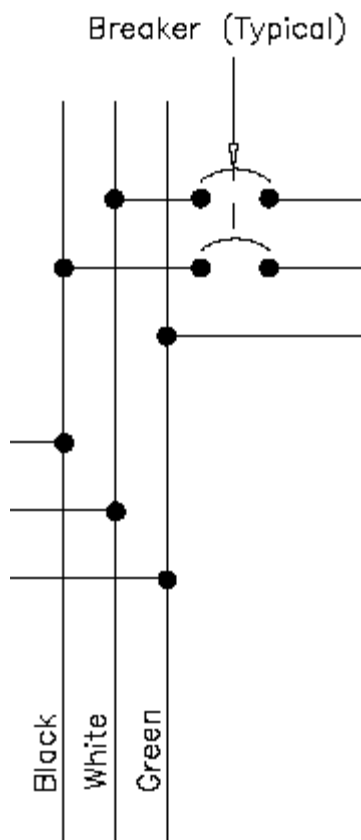
Like the DC system, the wiring to the AC system is not bundled and properly supported, and several terminations appear browned. In addition, from all appearances, the wiring and branch circuits have not been reconfigured to accommodate the electrical demands of the electronic laboratory in the salon. The system is also deficient by lacking a double pole breaker or reverse polarity indicating device, and by a lack of identification of the various branch circuits. The American Boat and Yacht Council (ABYC) recommends, *“Reverse polarity indicating devices providing a continuous visible or audible signal shall be installed in 120 V AC shore power systems and must respond to the reversal of the ungrounded (black) and the grounded (white) conductors the polarity of the system must be maintained for the proper operation of the electrical devices in the system.”*

Consequently, efforts should be made to either replace all breakers with double pole breakers or to providing a Reversed Polarity indicator.
